# **Environmental Assessment for a New Landfill Footprint at the West Carleton Environmental Centre**

## **ARCHAEOLOGY EXISTING CONDITIONS REPORT**

## **Stage 1 Archaeological Assessment**

### **Ottawa Waste Management Facility Environmental Assessment City of Ottawa, Ontario**

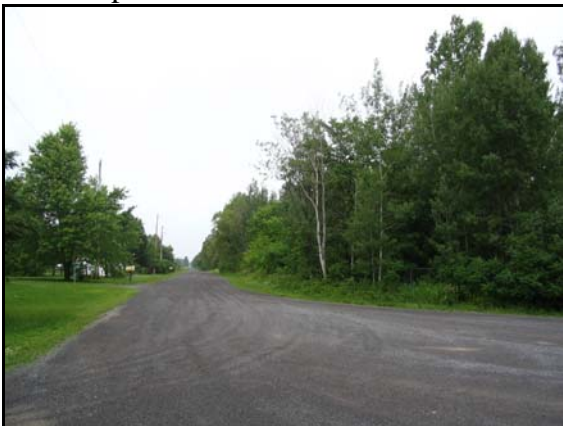
**Plate 1:** View to northwest along Wm Mooney Rd bordered by some modern residential properties. Note dips in road at drainage ditches.

The area of the West Alternative comprises portions of Lots 4 and 5, Concession 4, former Township of Huntley. Although some more recent structures have been added (Plate 1), these lands are characterized by historic log buildings and field layouts that still reflect the landscape depicted in the historic atlas of 1879. The land tends to be flat and poorly drained, but in places there are knolls or slightly higher ground (Plate 2), often associated with old farmsteads. There is potential for pre-contact and historic sites on the locales of higher ground, particularly along the treed western margin of the area (see ASI and GII 1999). There is also the potential for historic sites within 100 metres of Richardson Sideroad and William Mooney Road.

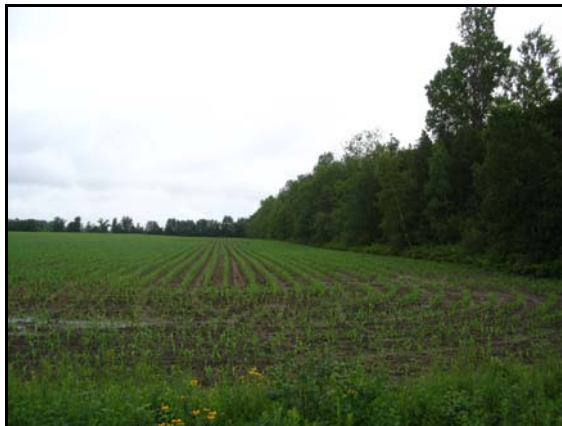
**Plate 2:** View to northeast from W. Mooney Rd. Woodlot edged by cedar and stone fence. Low rise at left of photo. Similar to landscape west of road.

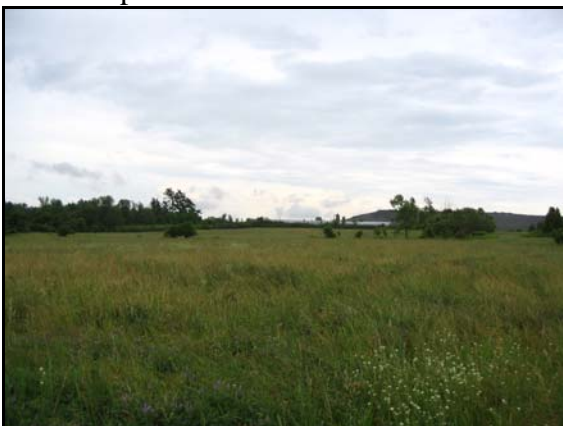
**Plate 3:** View to southeast across open fields edged by tree lines. Factory roof and landfill hill in background.

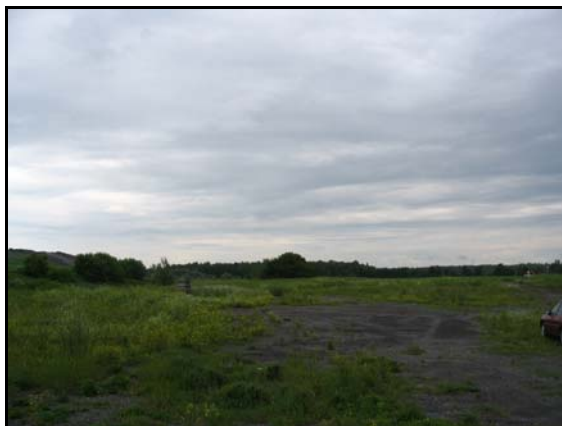
**Plate 4:** View to southwest across graded land behind factory. Fields in background are undisturbed.

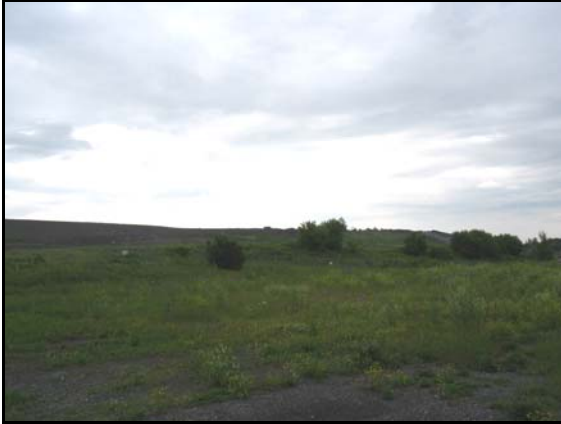
has been almost entirely disturbed by the existing facility (Plates 9, 13 and 14), by grading and aggregate extraction (Plate 5), and by construction of stormwater ponds along the southeast margin (Plate 11). The south and west margins are low and wet.

**Plate 5:** View to south across graded land behind factory. Landfill hill at left.

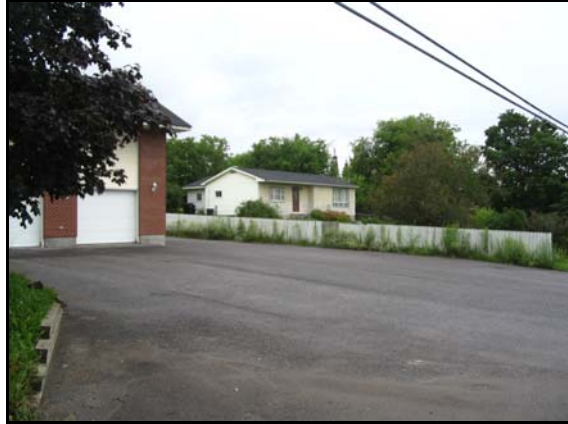
**Plate 6:** View to west from Carp Road. Modern residences adjacent to road south of factory.

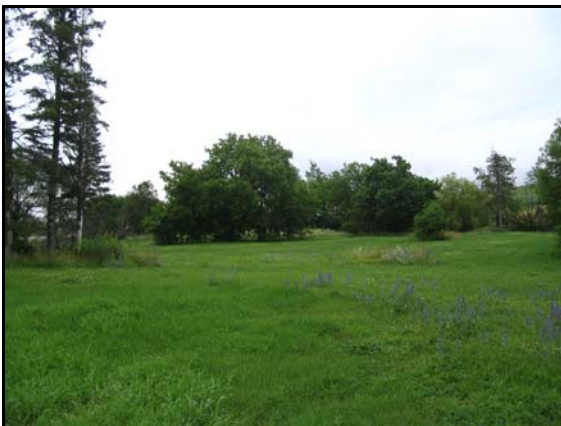
There is potential for archaeological sites in three locales. One is at the east (southeast) corner of the expansion area where a small remnant of the historical agricultural landscape survives between residential properties and the existing WM facility entrance (Plates 7 and 8). The second is in the west corner of the area where there is a low knoll beyond the low area near the road (Plate 2). The third is the woodlot in the south corner of the expansion area (west corner of the existing property).

There is potential for archaeological sites in two locales. One, along Carp Road just north of the main entrance to WM's facility, includes a remnant of the historical landscape (Plates 7 and 8). The other is the woodlot in the west corner of the existing property.

**Plate 7:** View to southeast, small area of remnant agricultural landscape. Carp Road at left.

1. A Stage 2 archaeological assessment should be conducted within all undeveloped lands in the selected area of construction impact: West Expansion Alternative (Figure 3-1); North Expansion Alternative (Figure 3-2); and Build Over Alternative (Figure 3-1). This work will be done in accordance with the Ministry of Culture's Stage 1-3 Archaeological Assessment Technical Guidelines (2006) in order to identify any archaeological remains that may be present in advance of any construction.

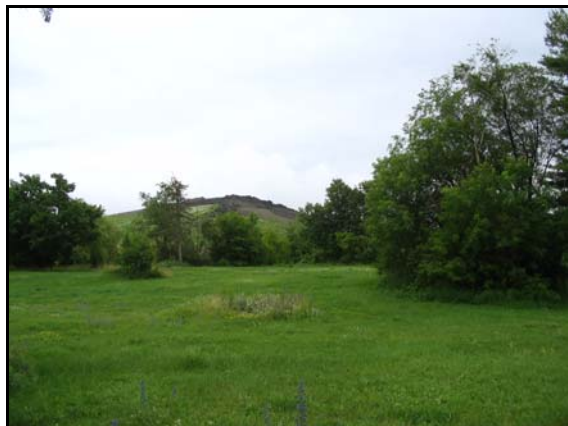
**Plate 8:** View to southwest, small area of remnant agricultural landscape with archaeological potential.

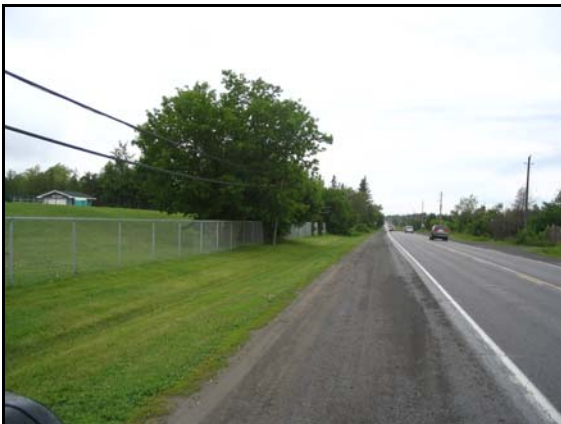
**Plate 9:** View to southeast along Carp Road near main entrance to WM facility. Disturbed ROW and adjacent lands.

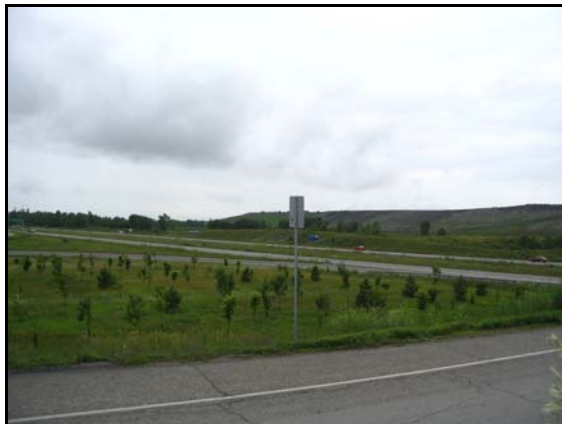
**Plate 10:** View to west across Hwy 417 from Carp Road. Note berm along southeast edge of existing facility and landfill hill.

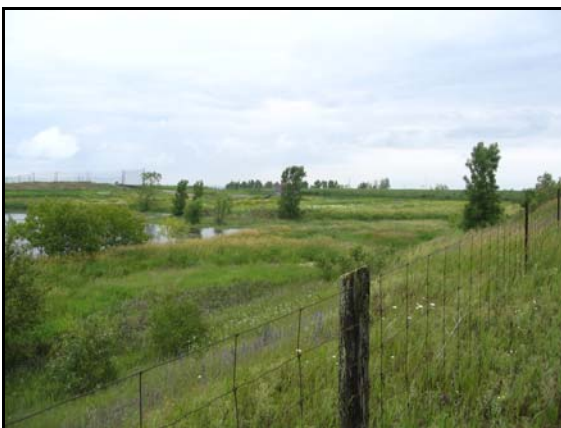
**Plate 11:** View to north-northeast from berm along southeast edge of existing WM facility. Stormwater management leachate ponds in distance.

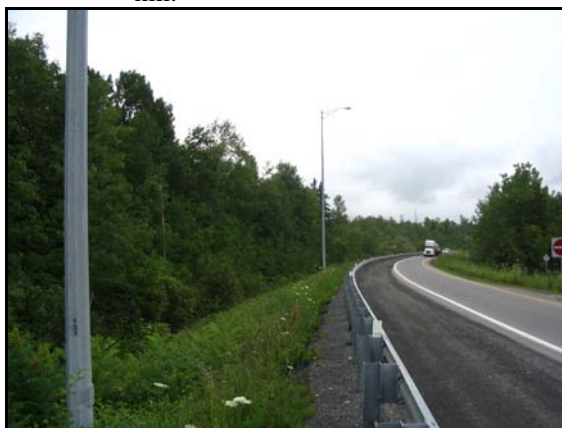
**Plate 12:** View to east along ramp from Hwy 417. Adjacent ditch and lands are disturbed and wet.

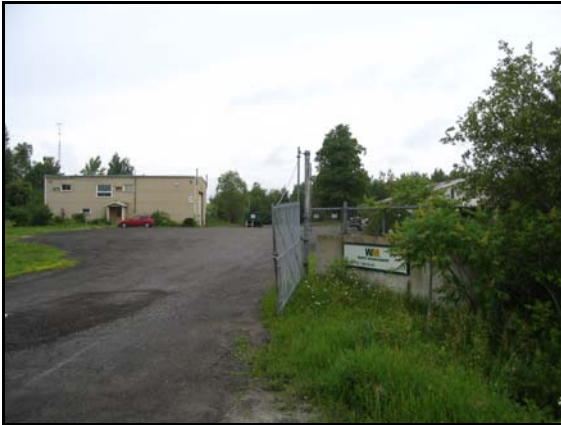
**Plate 13:** View to northeast, rear entrance of SM facility.

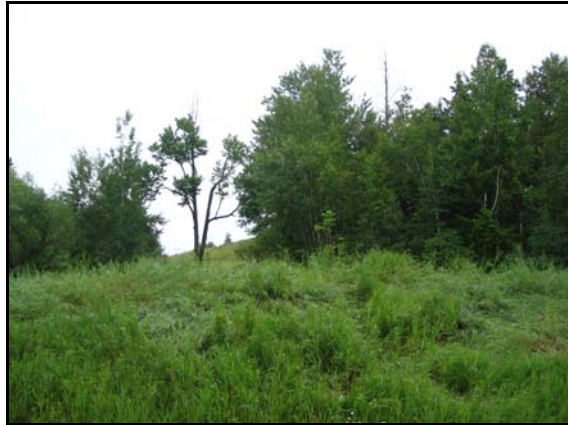
**Plate 14:** View to northeast, grass-covered berm in foreground surrounds existing facility. Edge of landfill hill rises behind trees.
